# Recreational Use Attainability Analysis for White Oak Creek (0303B) in the Sulphur River Basin

Prepared for:  
Texas State Soil and Water Conservation Board  
Project 16-60

Texas Institute for Applied Environmental Research  
Tarleton State University  
Stephenville, Texas

TR1708

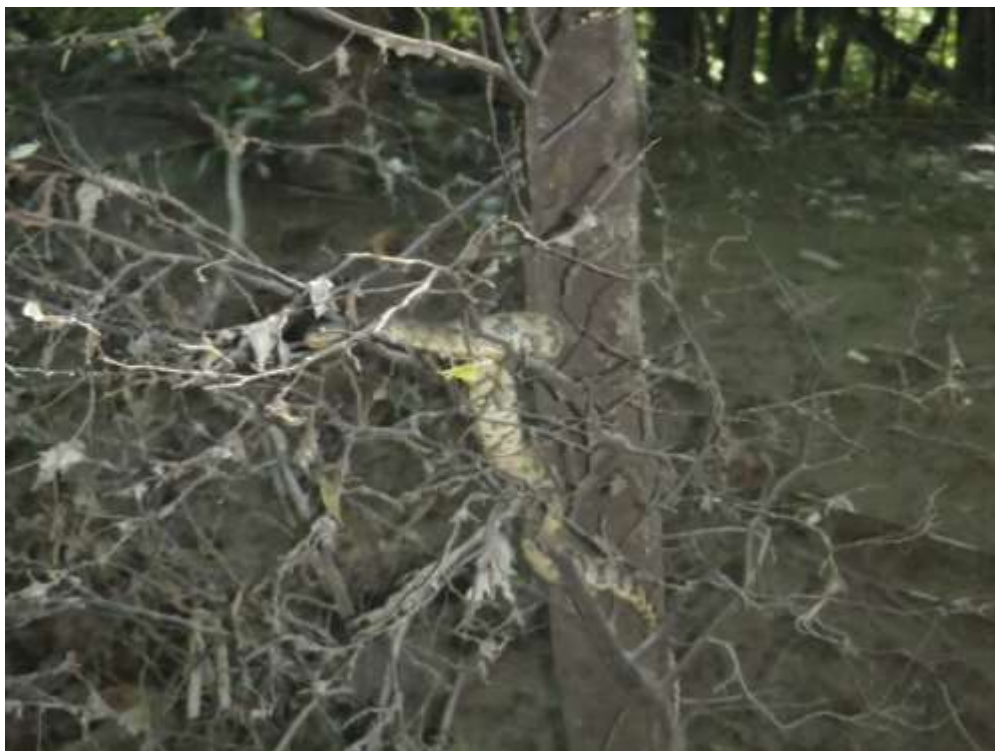
**Figure 4.27** Photograph of White Oak Creek Site WH11 taken on June 23, 2016. Left bank, diamondback water snake (*Nerodia rhombifer*) in tree hanging over the creek.

water snakes were seen throughout the 300-m stretch including one in a tree on the banks (Figure 4.27). Live and dead fish, and turtles were seen while surveying as well as a bird feather floating in the water. The only garbage encountered was a glass bottle and an empty ice chest. While no evidence of human recreation was observed at WH11, trotlines hanging from tree limbs were encountered during the boat ride to this site.

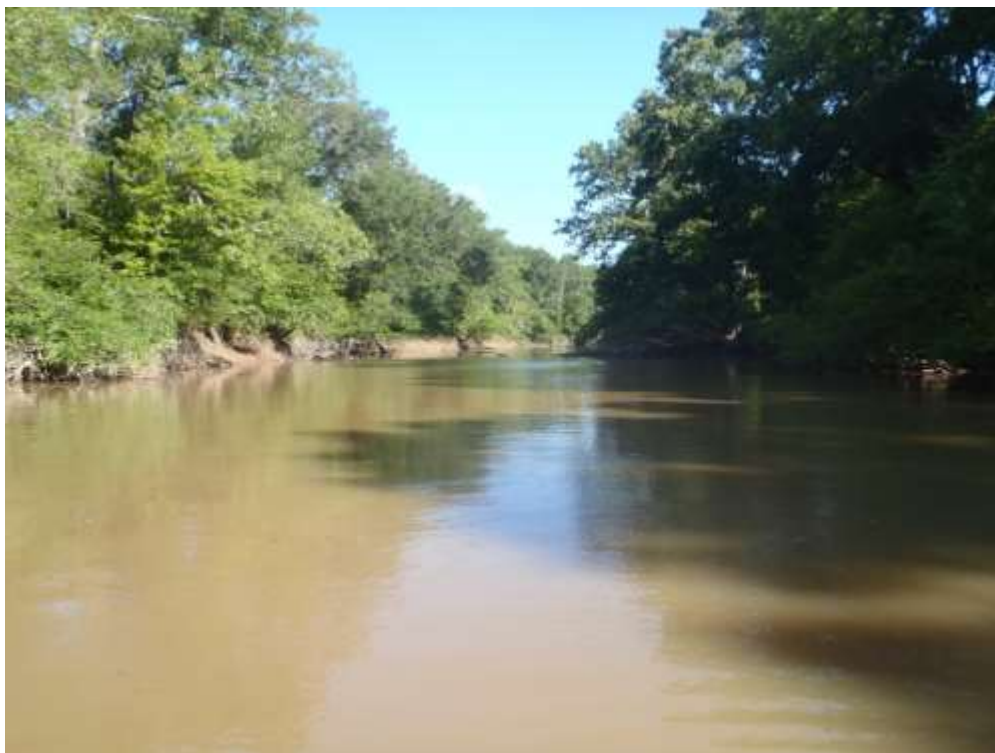
**Figure 4.28** Photograph of White Oak Creek Site WH12 taken on June 23, 2016. Upstream view of 0-m transect.

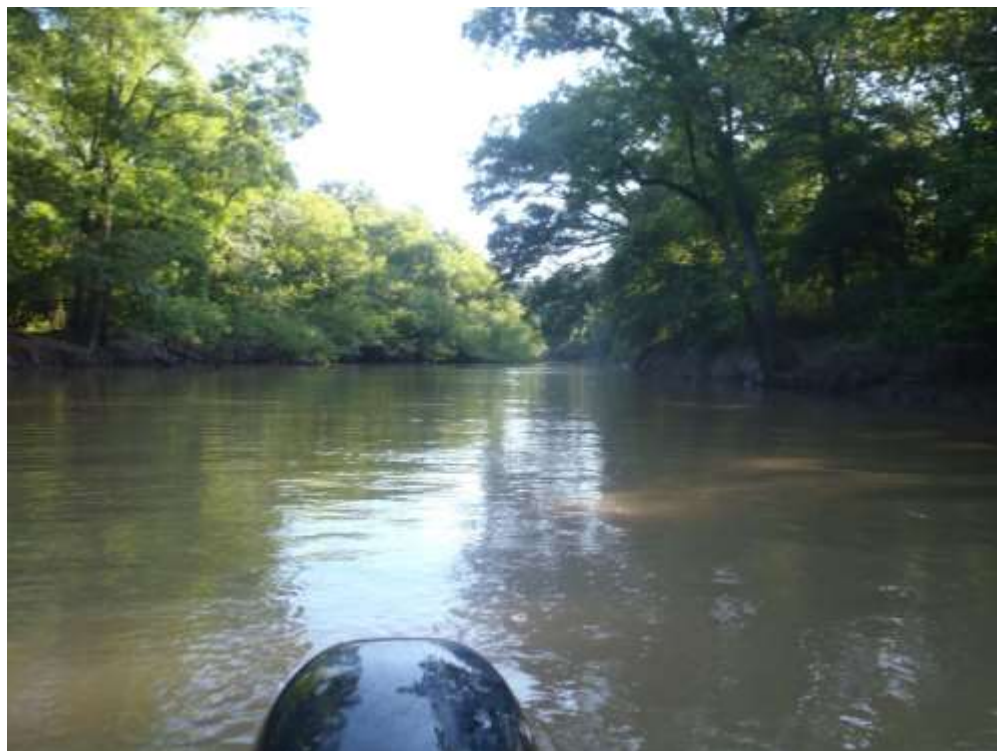
**Figure 4.29** Photograph of White Oak Creek Site WH13 taken on June 23, 2016. Upstream view of 300-m transect.

White Oak Creek at site WH13 was accessed on June 23, 2016 and August 11, 2016. This site is located 20.18 miles from the confluence with the Sulphur River. Stream corridor was densely forested on both sides much like WH12 (Table 4.5 and Figure 4.29). Banks were steep and slippery. Accessibility was difficult given the roughly 0.83 mile boat ride from the public boat ramp at Hill Hole (Table 4.6). No other roads exist within the White Oak WMA to gain access to Site WH13.

The site was non-wadeable during both surveys with average thalwegs greater than 1.5 m (Table 4.6). Flow was high during both surveys but the water level was noticeably lower during the second survey (Figures 4.29 and 4.30). The channel and corridor appearance at this site was similar to the previous three sites. Widths during both the first and second survey ranged from 26 m at the widest point to 12 m at the narrowest with a typical average width of 14 m.

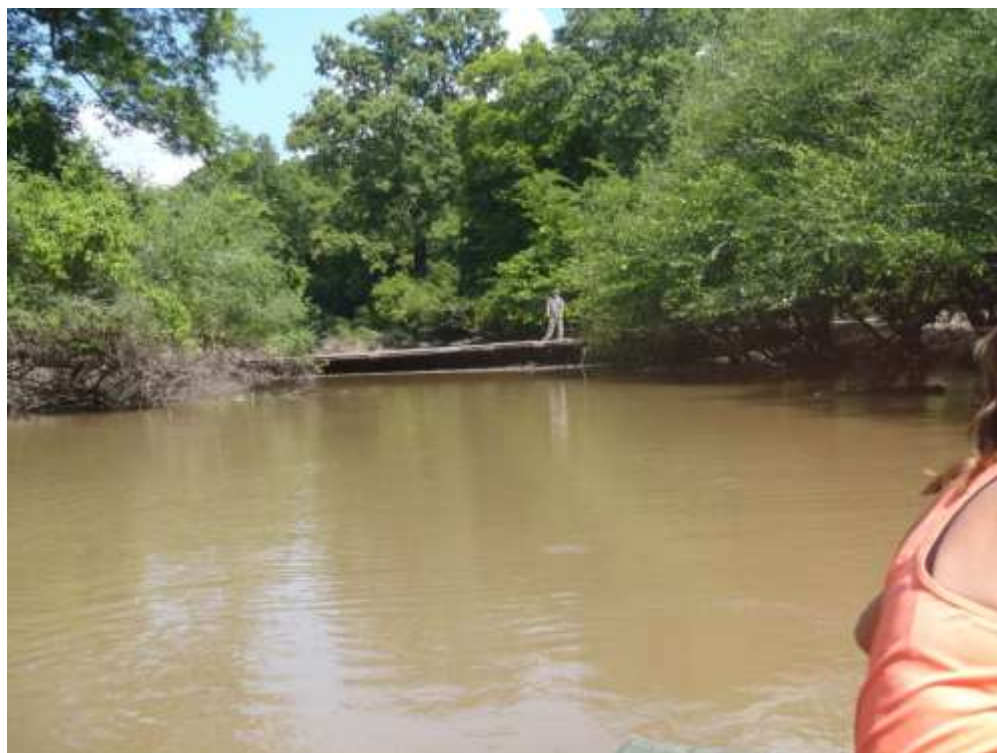
**Figure 4.31** Photograph of White Oak Creek Site WH14 taken on June 22, 2016. Downstream view of 0-m transect. TIAER personnel in photo.

White Oak Creek at WH14 was accessed June 22 and August 11, 2016. This site is located 21.01 miles from the confluence with the Sulphur River at the Hill Hole bridge crossing and public parking lot within the WMA (Table 4.11). The accessibility of the site was moderately easy due to potential public access, however, steep, slippery banks made launching the boat challenging (Table 4.6). The dominant substrate was mud and clay with a native forest corridor (Table 4.5 and Figure 4.31).

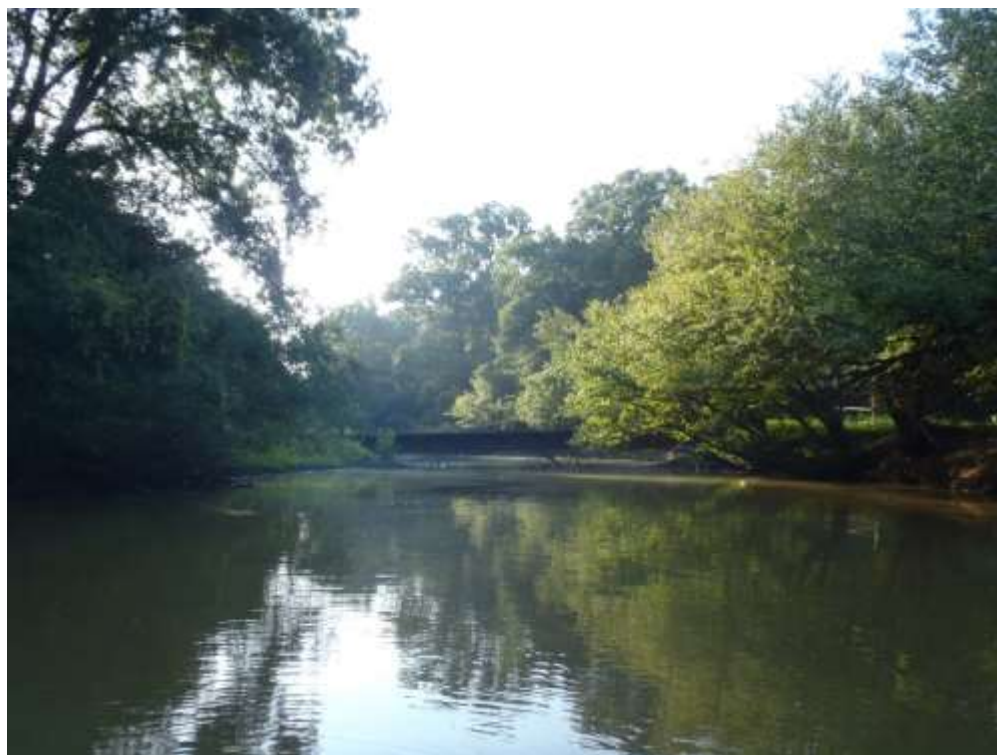
**Figure 4.32** Photograph of White Oak Creek Site WH14 taken on August 11, 2016. Downstream view of 0-m transect.

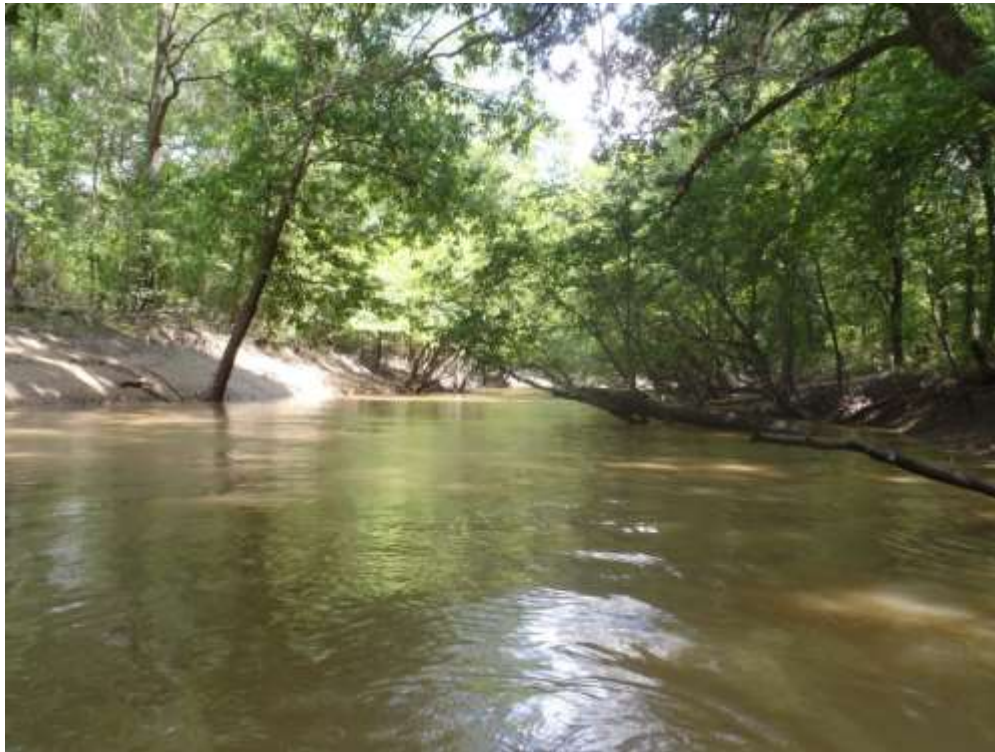
**Figure 4.33** Photograph of White Oak Creek Site WH15 taken on June 22, 2016. Downstream view of 0-m transect.

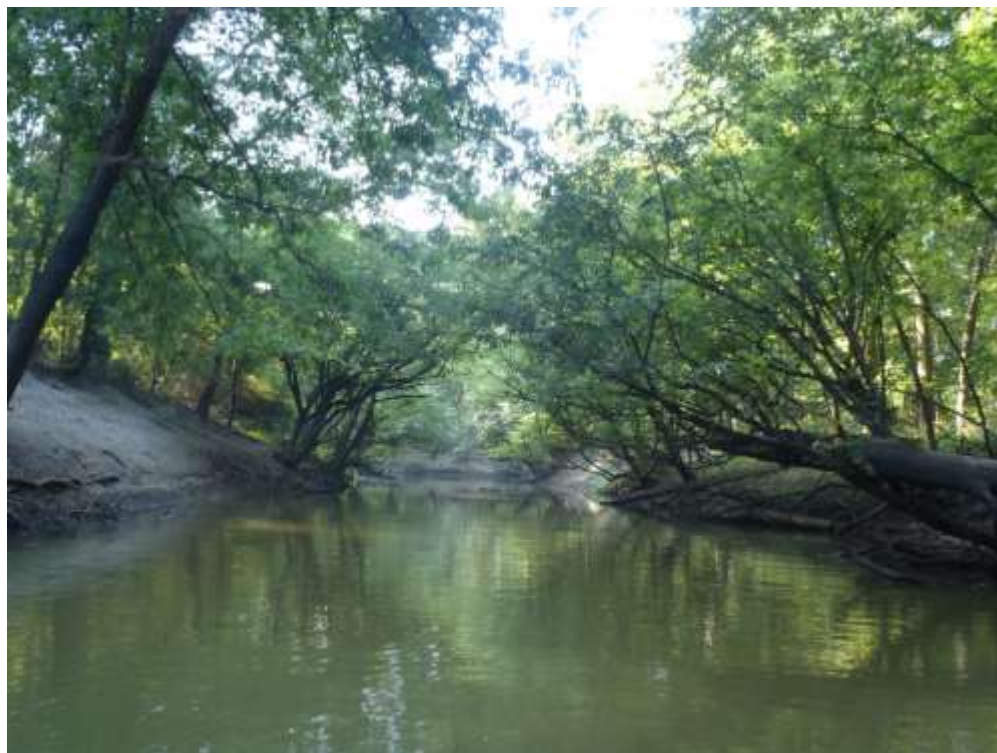
**Figure 4.34** Photograph of White Oak Creek Site WH15 taken on August 11, 2016. Downstream view of 300-m transect.

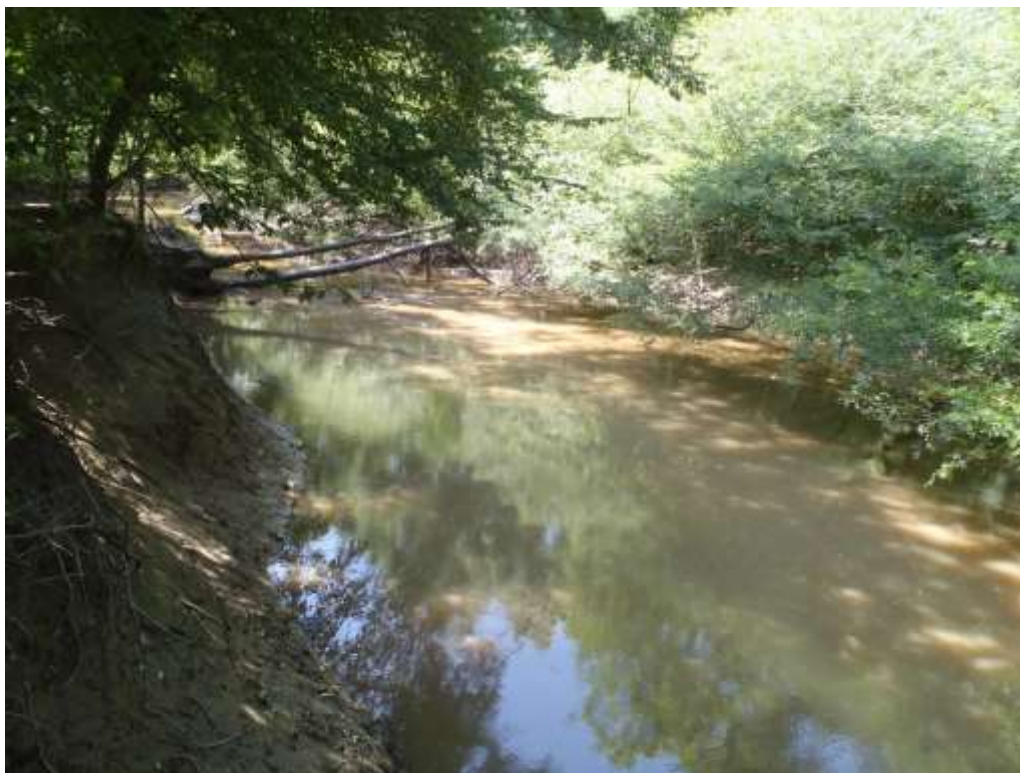
**Figure 4.35** Photograph of White Oak Creek Site WH16 taken on June 22, 2016. Upstream view of the 300-m transect.

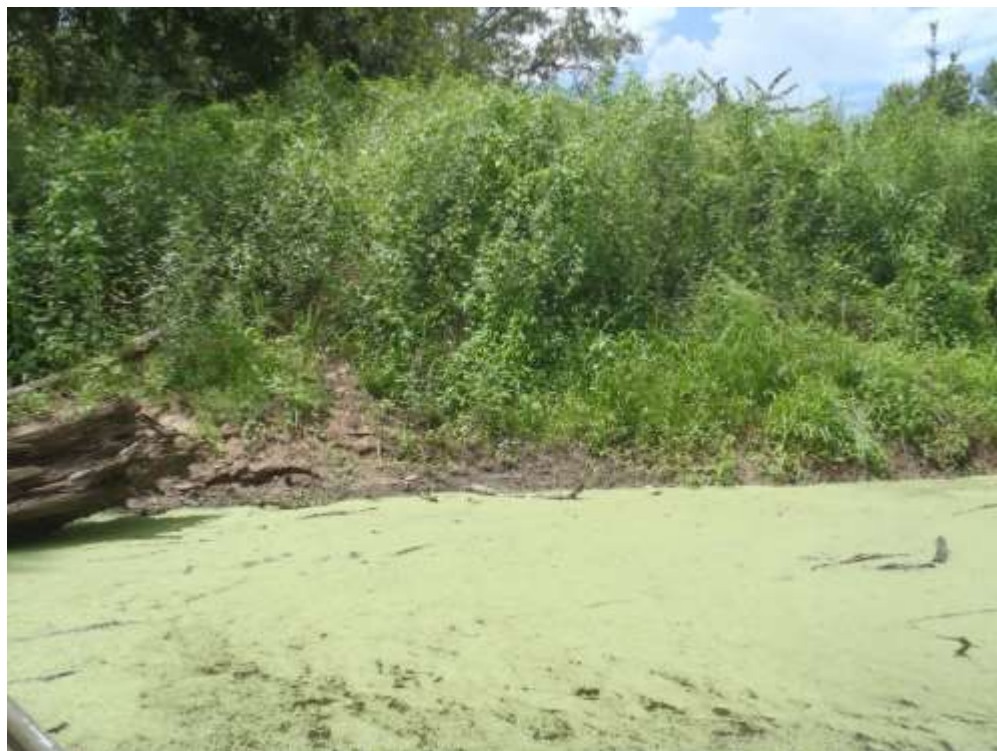
**Figure 4.53** Photograph of White Oak Creek taken on August 9, 2016 during the second attempt to access Site WH23. Right bank view at the logjam preventing access to WH23.

Traveling to Site WH23 in the boat was possible; however, a large logjam (Figure 4.52) was encountered on both survey dates that blocked access to the entire stretch of transects. Depths up to this logjam were greater than 1.5 m, thus, non-wadeable. The water was brown and turbid and the surface was covered with scum, debris, and duckweed. The right bank was steep and densely vegetated (Figure 4.53). Similarly, the left bank was overgrown and muddy. These bank conditions prohibited bank access and therefore circumventing the logjam.

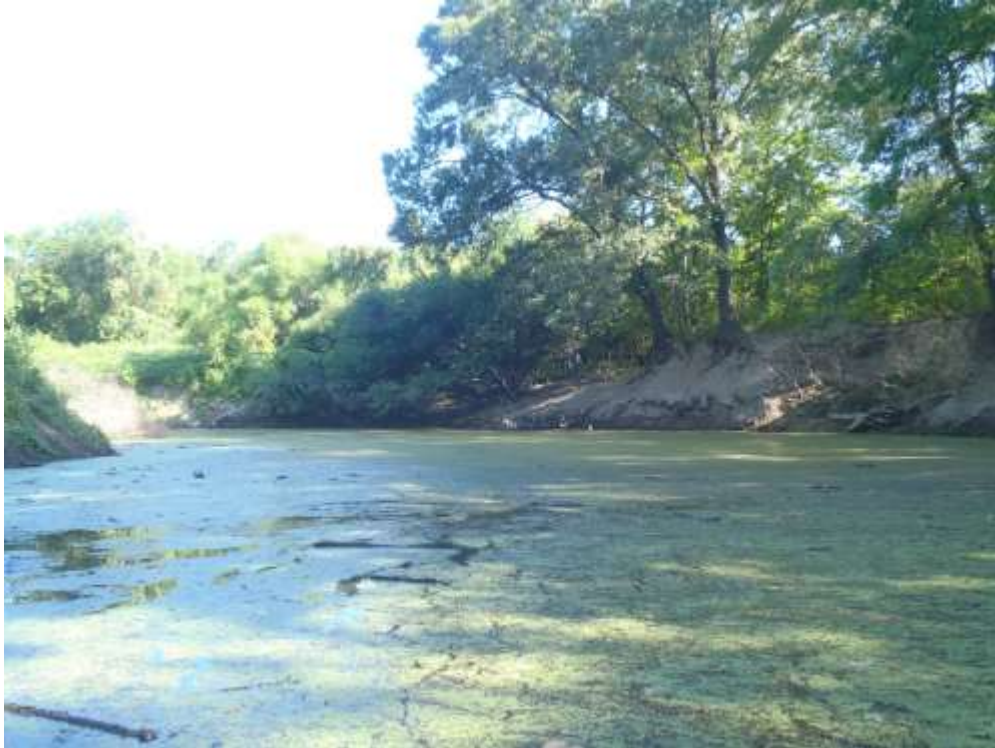
**Figure 4.54** Photograph of White Oak Creek Site WH24 taken on July 20, 2016. Upstream view of the 0-m transect.

Aesthetic appearance of the water and wildlife observations for the site during each survey have been previously provided in Tables 4.9 and 4.10. Brown colored water, excessive amounts of duckweed, foam, scum, and other floating debris were characteristic of the water surface during both surveys (Figures 4.54 and 4.55). Aquatic vegetation was common and algae was rare during both surveys. No odor was ever detected (Table 4.9 and 4.10).

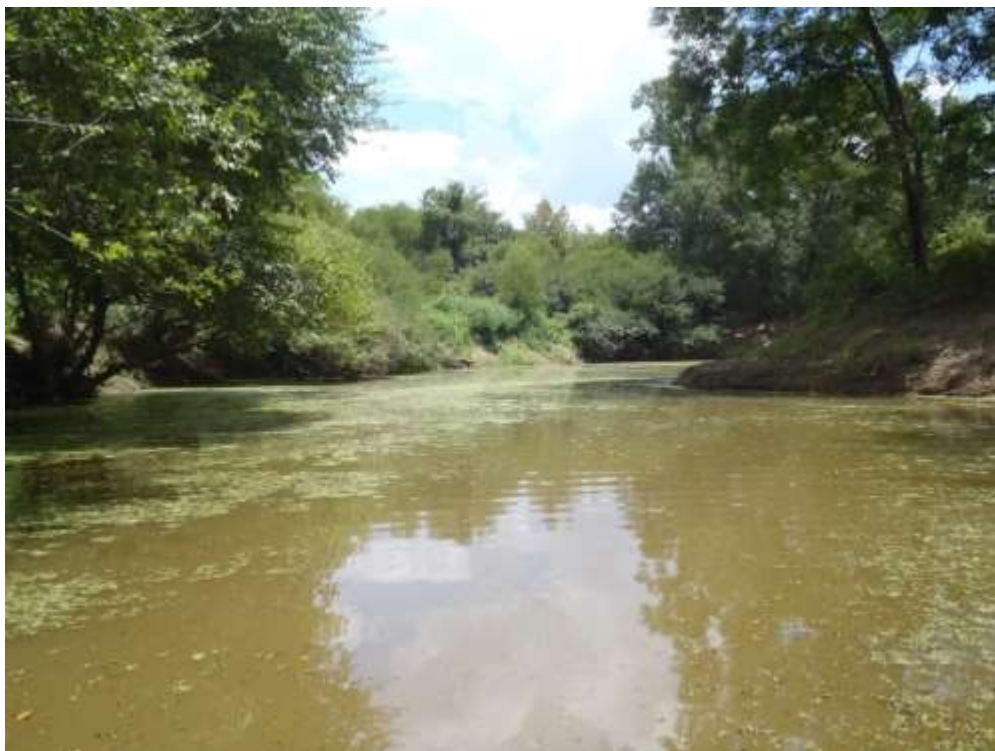
**Figure 4.55** Photograph of White Oak Creek Site WH24 taken on August 9, 2016. Downstream view of the 150-m transect.

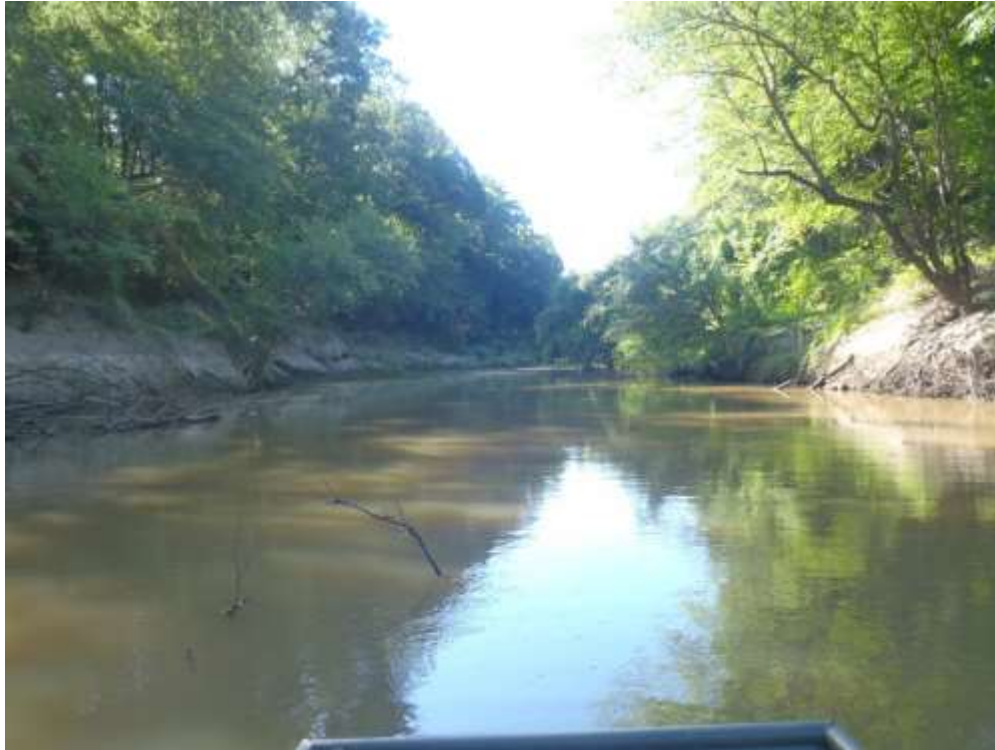
**Figure 4.56** Photograph of White Oak Creek Site WH25 taken on July 20, 2016. Downstream view of the 0-m transect.

This site is located in a forest dominated corridor (Table 4.5). Access to the stream was difficult due to lack of public accessibility, steep slippery banks, and dense vegetation. Logjams and tree debris littered the stream at this location. Even then, navigating the stream in a boat was the easiest way to reach this portion of White Oak Creek. Figures 4.56 and 4.57 depict the appearance of the site during each of the surveys.

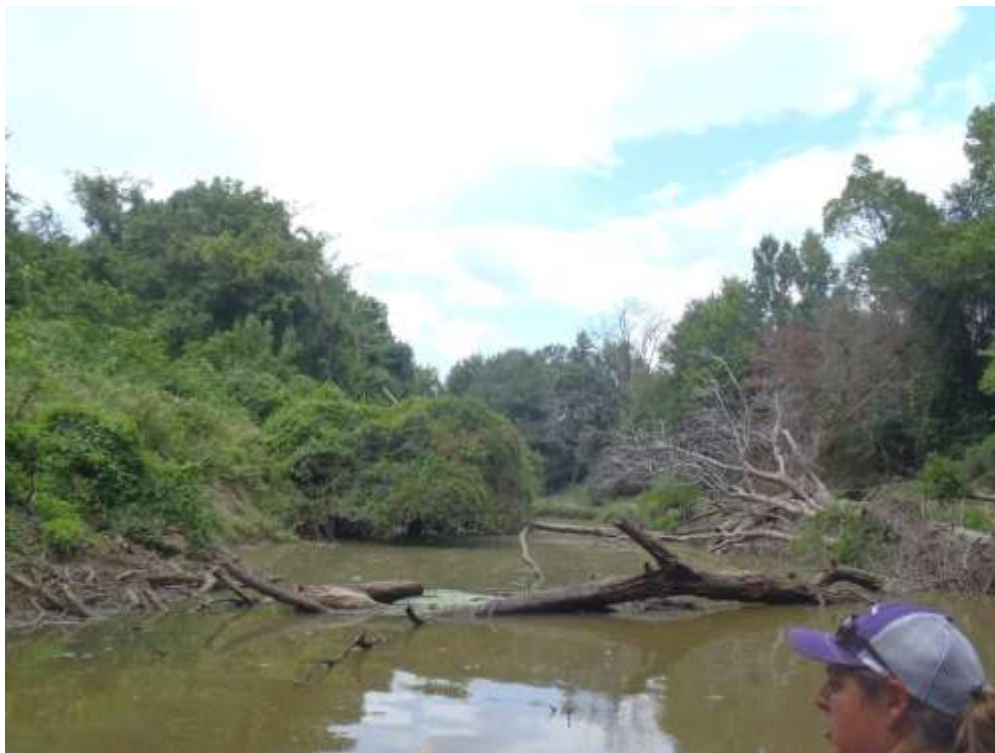
**Figure 4.57** Photograph of White Oak Creek Site WH25 taken on August 9, 2016. Upstream view of the 150-m transect. TIAER personnel in photo.

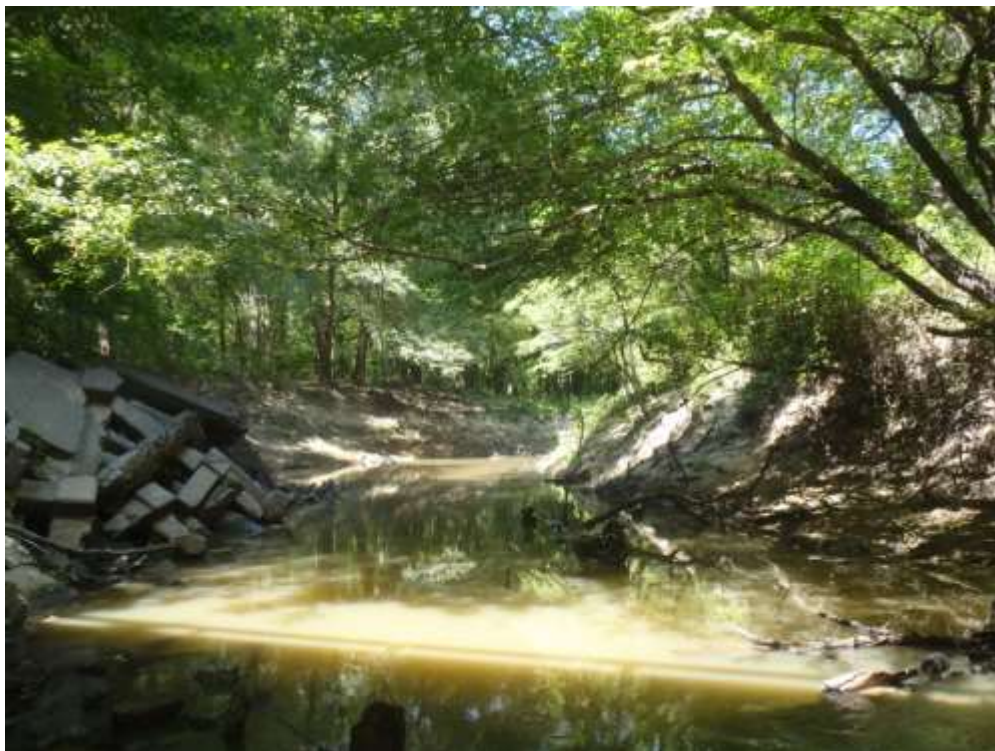
**Figure 4.58** Photograph of White Oak Creek Site WH26 taken on July 20, 2016. Upstream view of the 150-m transect.

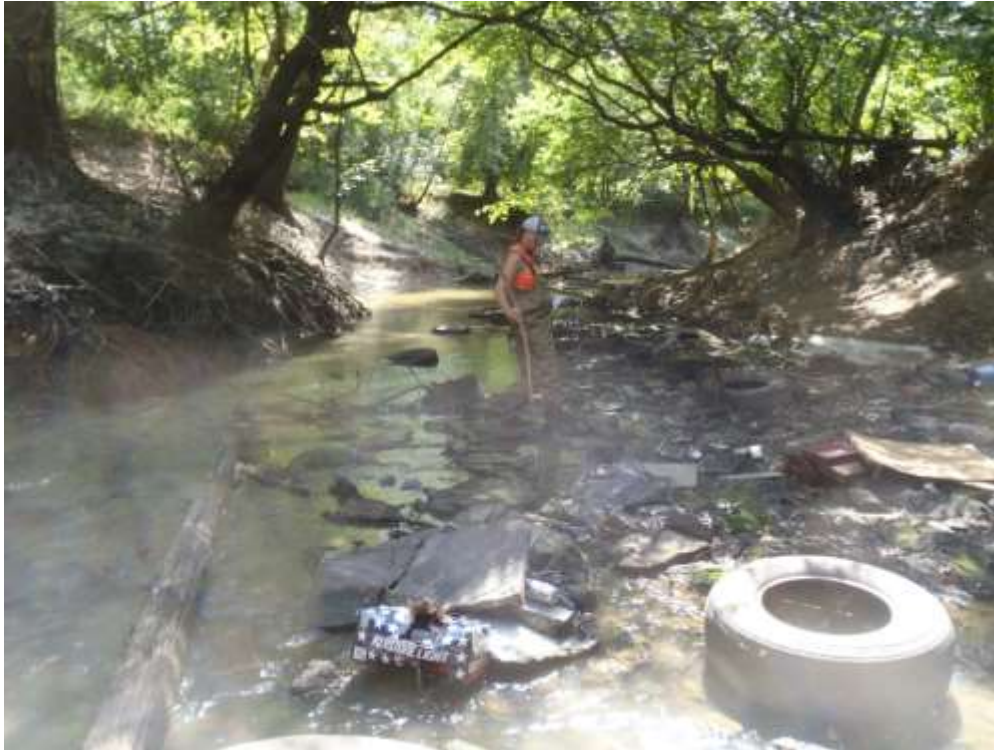
**Figure 4.59** Photograph of White Oak Creek Site WH26 taken on August 9, 2016. Downstream view of the 150-m transect and excessive garbage. TIAER personnel in photo.

As previously mentioned, this site contained an abundant amount of garbage (large and small) in the stream channel at the 150-m transect. This could be contributed to this transect being at a road crossing and local residents using this site's bridge as a dump. Large items in the stream channel included a mattress, child's bicycle, rolled carpet, a glass door, a plastic tarp, an oscillating fan, an artificial Christmas tree, several tires, large steel pieces, and a water hose. Typical garbage, such as glass bottles and aluminum cans, were present as well.

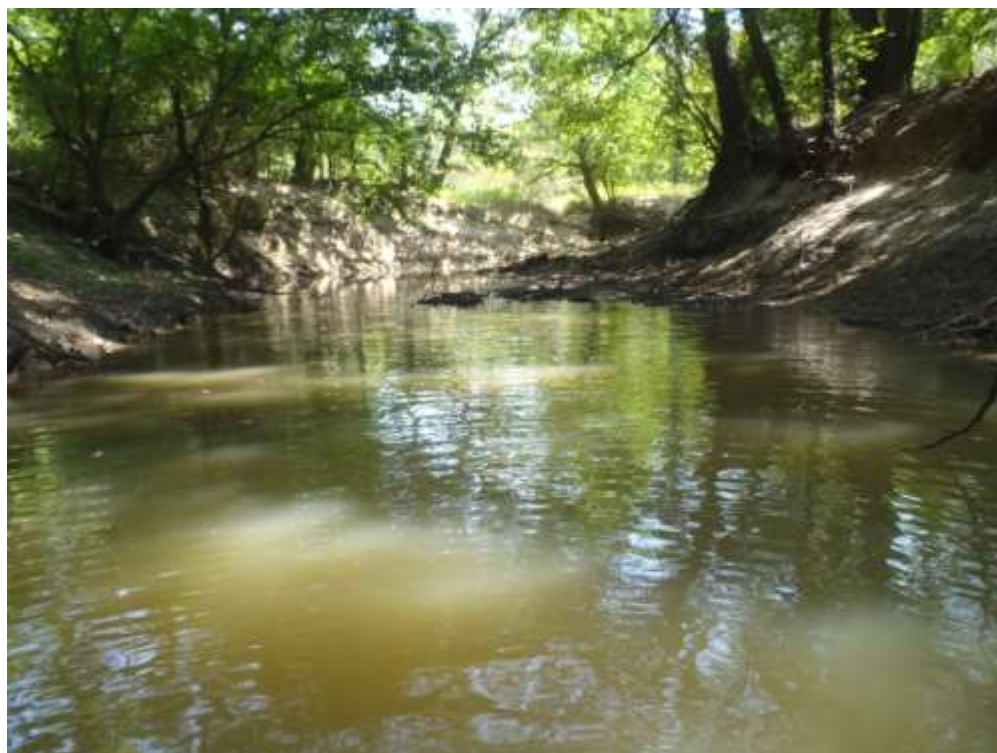
**Figure 4.60** Photograph of White Oak Creek Site WH26 taken on August 9, 2016. Downstream view of the 0-m transect.

White Oak Creek at Site WH26 was visited on July 20 and August 9, 2016. This site was located on White Oak Creek north northwest of Mount Vernon in Franklin County on CR 2100. Site WH26 was publically accessible at the crossing but was fenced on the left and right riparian areas of the stream. The large, stream corridor consisted of primarily native forest on both the right and left banks (Table 4.5). Access to the stream was difficult due to the steep, slippery banks, and large amounts of garbage directly up and downstream of the road crossing (Figures 4.58 and 4.59). The 150-m transect was the only one with large garbage. It was noted by TIAER personnel that steps were carved out of the bank directly at the bridge. It appeared the steps were created with a shovel or similar tool. The general appearance of the remaining transects is depicted in Figure 4.60.

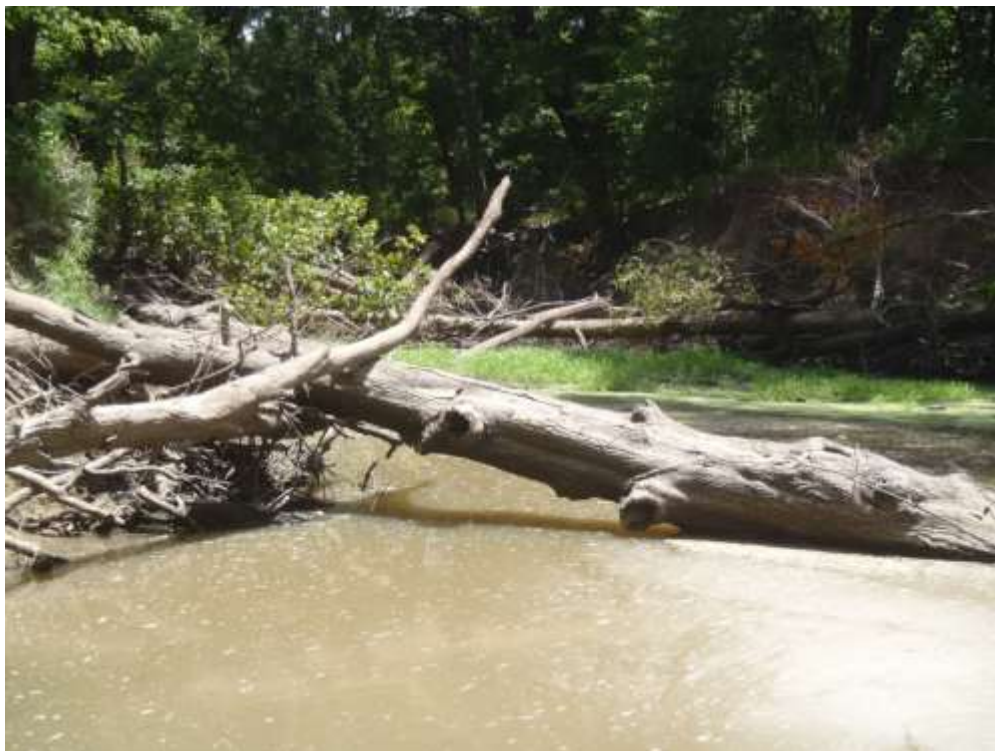
**Figure 4.61** Photograph of White Oak Creek taken on July 20, 2016. Logjam preventing access to WH27.

White Oak Creek at Site WH27 was visited on July 20 and August 9, 2016. This site was located on White Oak Creek approximately half a mile downstream of SH 37 in Franklin County. During the initial reconnaissance trip, TIAER personnel were able to launch a small boat at the intersection of White Oak Creek and SH 37 and navigate to WH27. However, fallen water levels exposed a large logjam (Figure 4.61), which prevented TIAER personnel from navigating via boat to Site WH27. Non-wadeable depths encountered while traversing to the site prohibited access to the site via the stream channel. Near vertical left and right banks with thick vegetation prohibited TIAER personnel from walking alongside White Oak Creek to reach site WH27.

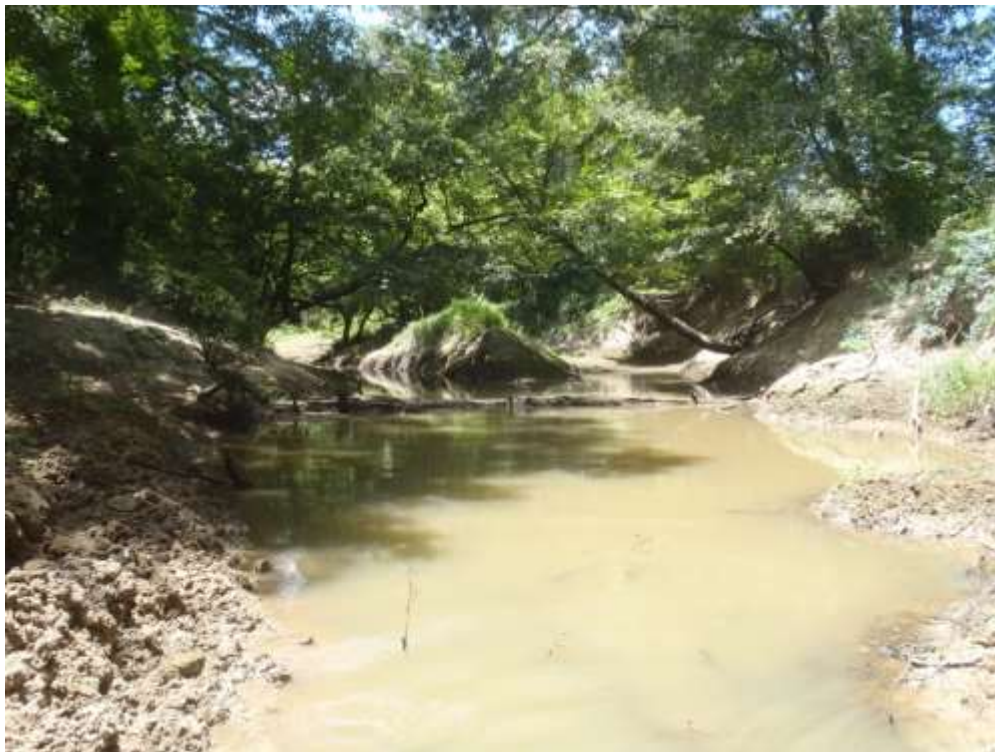
**Figure 4.62** Photograph of White Oak Creek Site WH28 taken on July 20, 2016. Upstream view of the 300-m transect.

The creek at this site passes through native, forest vegetation. The riparian area was large with trees and native forest leading directly up to the edge of the stream bank (Table 4.5). The dominant substrate at this site was primarily sand, silt, mud, and clay causing TIAER personnel to sink to their knees and making walking on the banks and through the channel very challenging. Figure 4.62 illustrates the general appearance of White Oak Creek at this site.

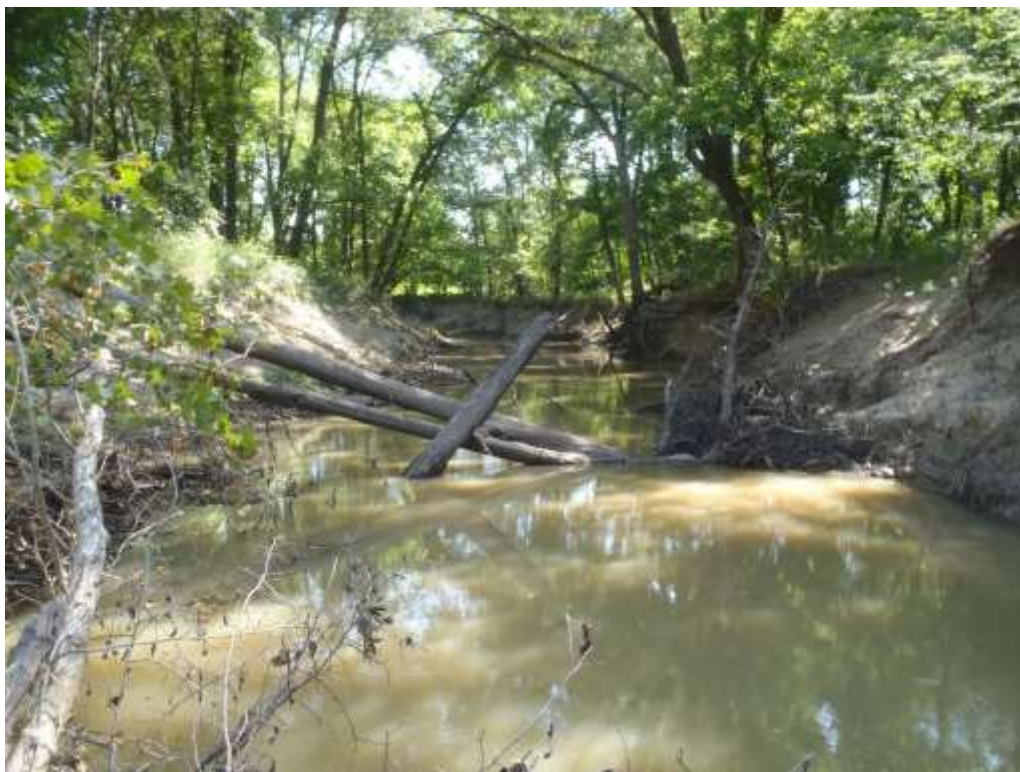
**Figure 4.63** Photograph of White Oak Creek Site WH28 taken on August 9, 2016. Downstream view of the 0-m transect.

Aquatic vegetation was absent during both surveys, but small fish were observed during the first survey. Algae cover was rare and a strong odor was common at this site during both surveys (Tables 4.9 and 4.10). Foam, scum, and bubbles on the water surface were observed throughout the 300-m reach during both surveys. Figure 4.63 depicts logjams and tree debris that was common throughout the 300-m reach.

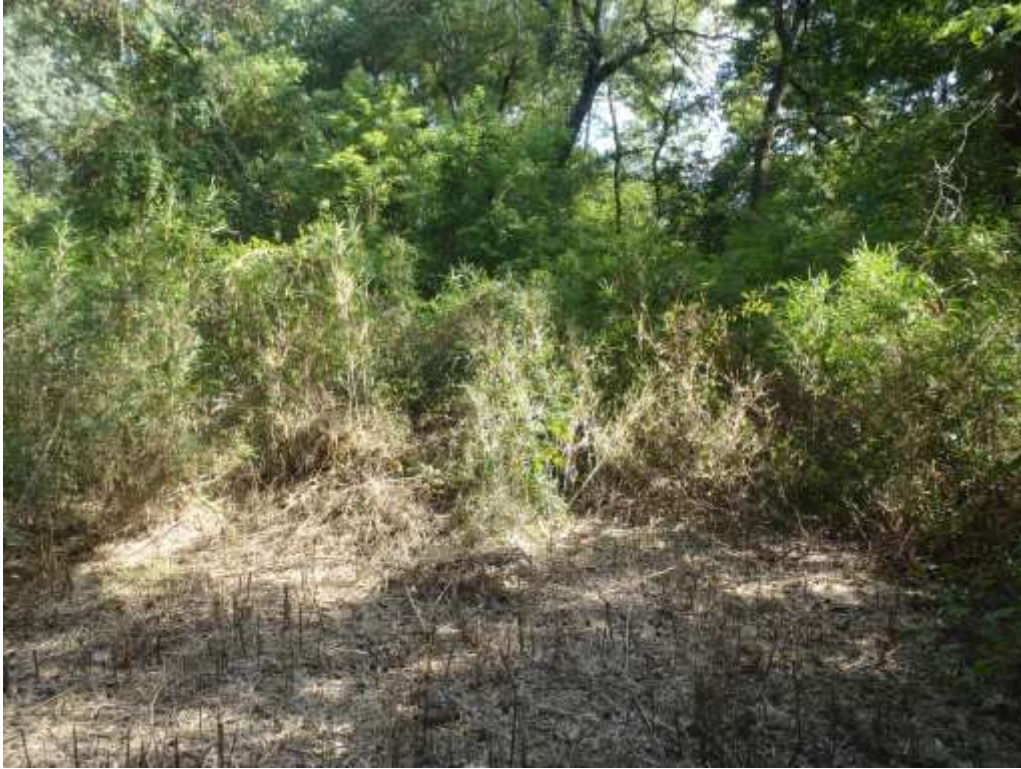
**Figure 4.66** Photograph of White Oak Creek Site WH29 taken on August 29, 2016. Thick vegetation at access point.

During transport to the site, the ATV's left front wheel dropped into a washed out culvert that was obscured by the tall vegetation. Additionally, multiple trees had fallen across paths previously taken, making traveling to this site very difficult. Some trees were able to be winched out of the way using the ATV; however, one tree was too large and heavy to be moved by the ATV (Figure 4.65). Once TIAER personnel were able to locate WH29, bamboo had grown too thick to pass through to access the bank (Figure 4.66). This site was not surveyed due to inaccessibility.

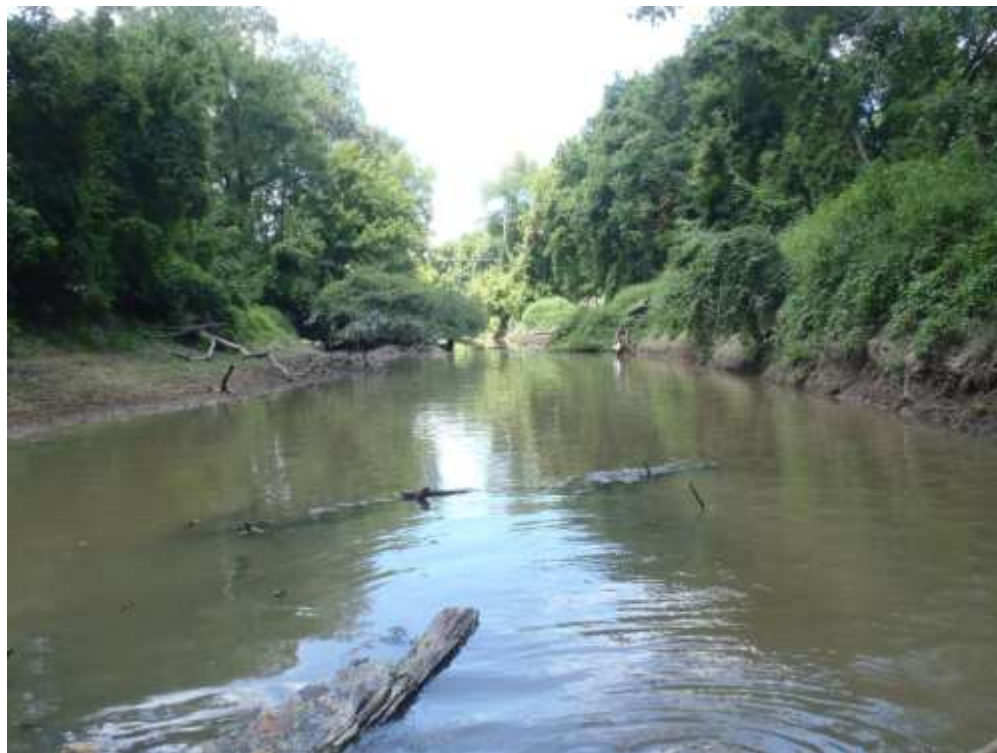
**Figure 4.67** Photograph of White Oak Creek Site WH30 taken on July 22, 2016. Upstream view of the 0-m transect.

The area had a mowed and maintained corridor making access to the creek easy despite the steep banks. However, beyond the bridge crossing, this site had thick, native forest vegetation reaching directly to the edge of the stream bank (Figures 4.67 and 4.68). The riparian area at this site was large throughout the full 300-m reach (Table 4.5).

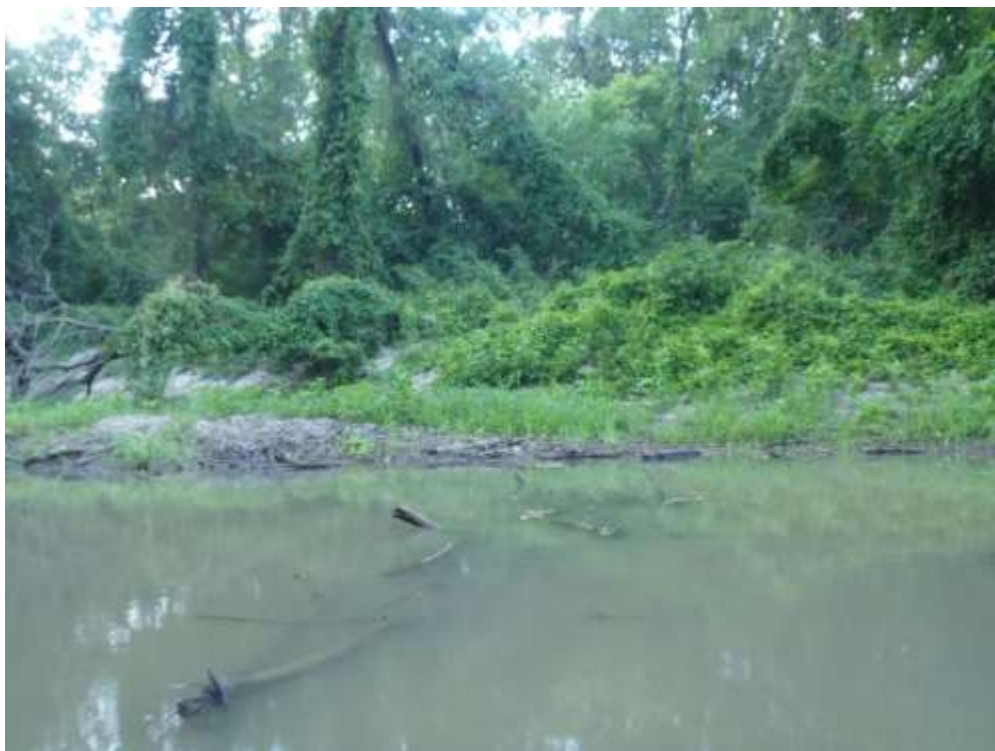
**Figure 4.68** Photograph of White Oak Creek Site WH30 taken on August 8, 2016. Right bank view of the 0-m transect.

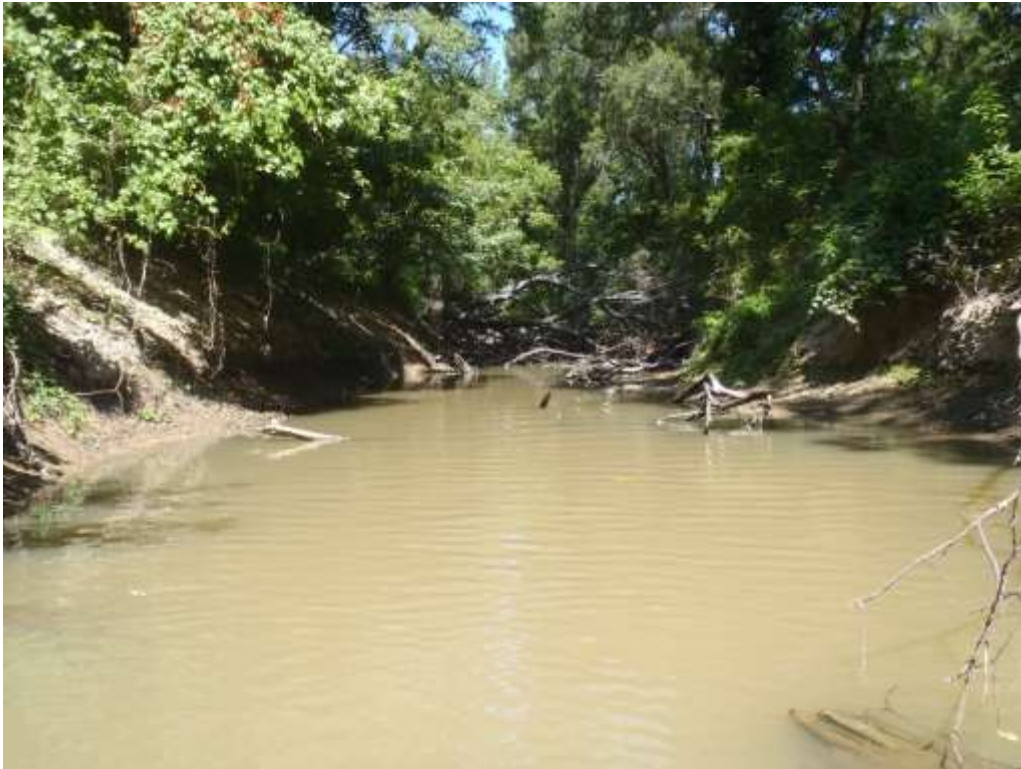
**Figure 4.69**      **Photograph of White Oak Creek Site WH31 taken on July 22, 2016. Upstream view of the 300-m transect.**

White Oak Creek at site WH31 was visited on July 22 and August 9, 2016. This site was accessed through a private property gate off CR 3524. Access was granted by the landowner to enter the property leading to the creek. TIAER personnel entered the property via a truck, but because of extremely dense vegetation and trees, an ATV was used to travel the approximate 1.5 miles to the access point. The large riparian area was densely forested on both the left and right banks and continued up to the stream bank (Table 4.5). Banks at this site were incredibly steep and slippery making stream access difficult. TIAER personnel had to use tree vines and roots as a ladder to climb out of the stream banks once the surveys were completed. Figures 4.69 and 4.70 depict the appearance of the site during each of the surveys.

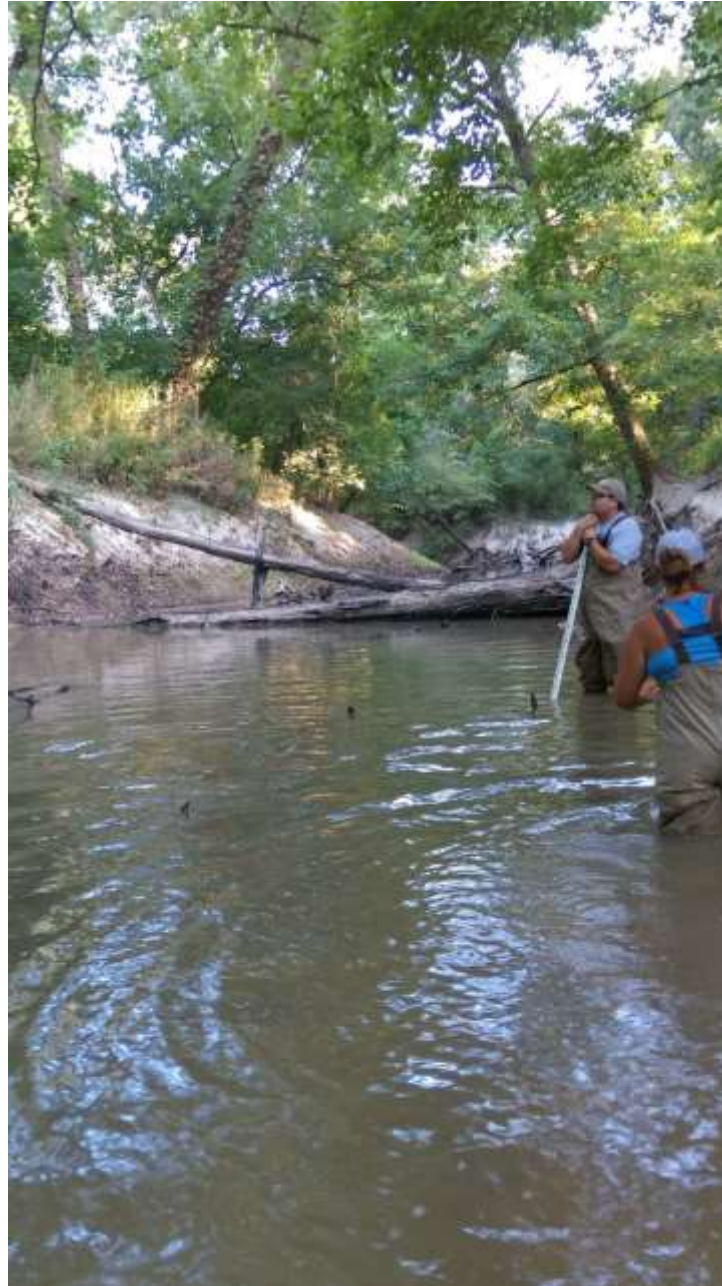
**Figure 4.70** Photograph of White Oak Creek Site WH31 taken on August 9, 2016. Upstream view of the 0-m transect. TIAER personnel in photo.

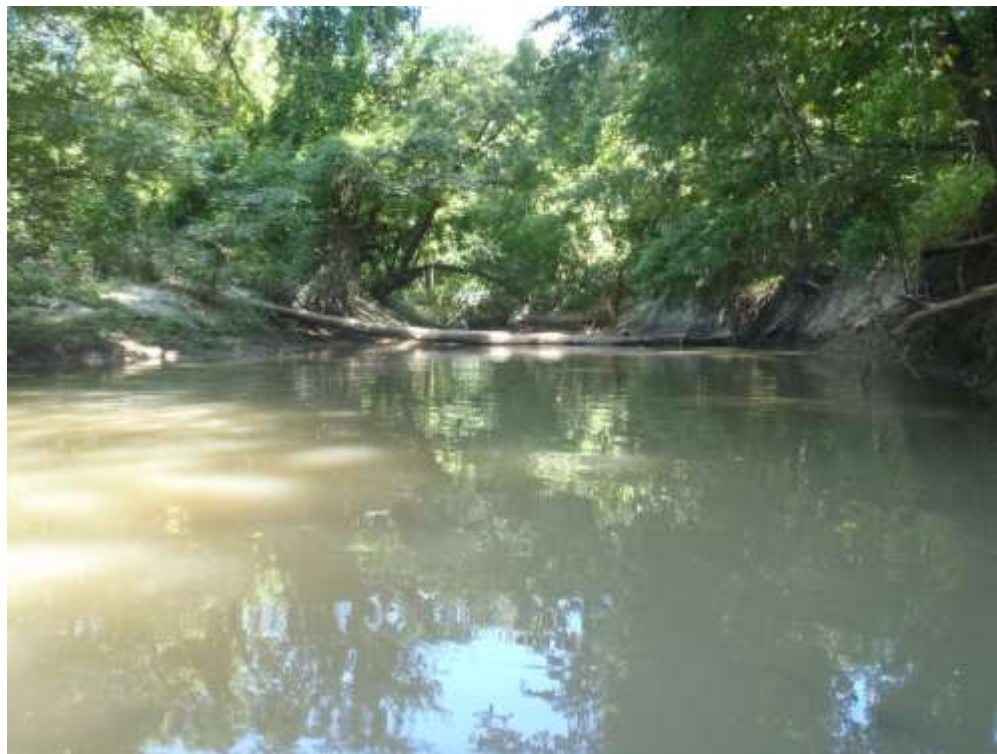
**Figure 4.71** Photograph of White Oak Creek Site WH32 taken on July 21, 2016. Upstream view of the 300-m transect.

White Oak Creek at Site WH32 was visited on July 21 and August 7, 2016. This site was accessed via a locked private property gate, approximately 1 mile from the public road. Access was granted by the landowner to enter the property leading to White Oak Creek Sites WH32, WH33, and WH34. The large riparian area was densely forested on both the left and right banks and continued up to the stream bank (Table 4.5). Banks at this site were incredibly steep, slippery, and poison ivy was abundant. These factors made stream access difficult. Additionally, this site contained a large amount of tree debris and large logjams (Figures 4.71 and 4.72) during both surveys making walking through the channel difficult.
